AFAC-TR-55-3

- Evaluation of Aircraft -
Armament Installation
(F-86F with 206 RK Guns)
Project Gun-Val (Title Unclassified)

- February 1955

AIR FORCE ARMAMENT CENTER
Air Research and Development Command
EGLIN AIR FORCE BASE, FLORIDA -

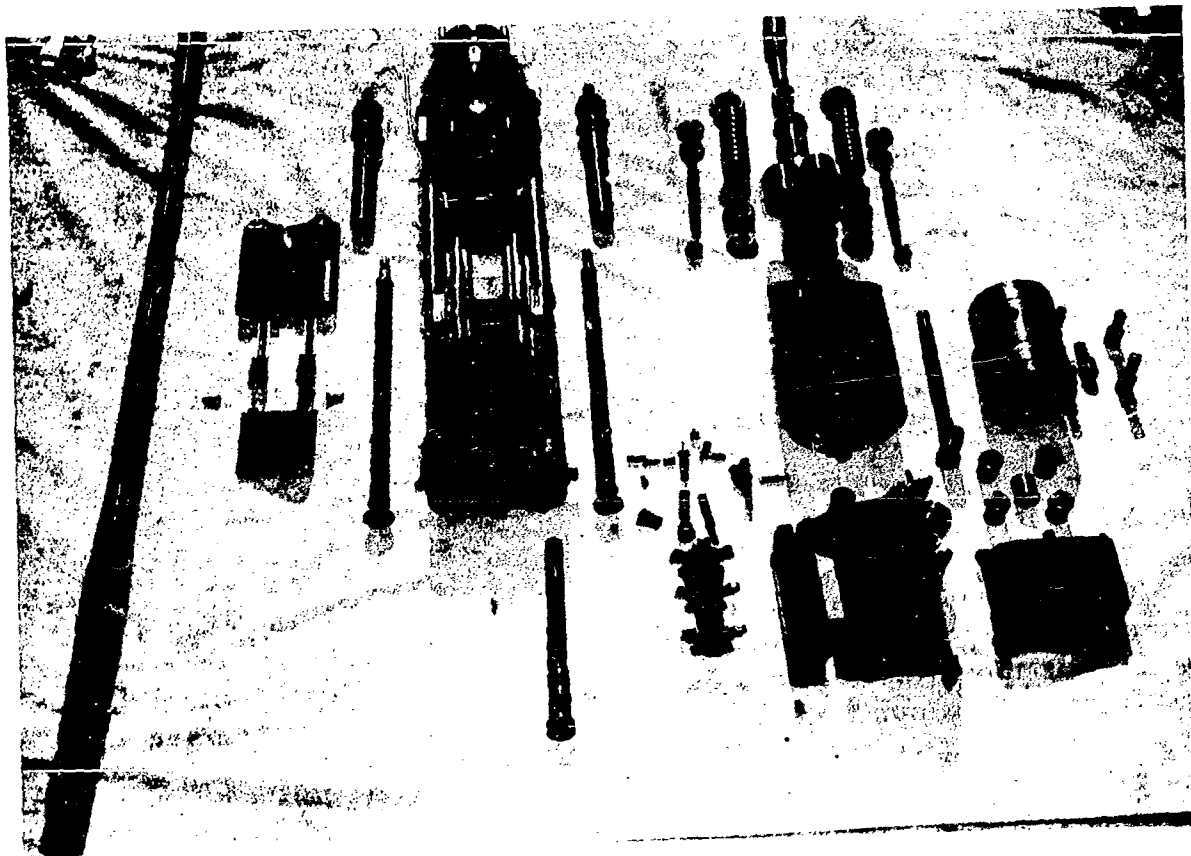
Fig. 1: 20mm 206 RK Gun

The Oerlikon 20mm 206 RK revolver gun (Figs. 1 and 2) is an automatic, gas-operated aircraft weapon, adaptable to either fixed or flexible mounting. It was designed to fire electrically-primed, link-belt-fed ammunition at a muzzle velocity of 3500 ft per sec and at a cyclic rate between 1600 and 1800 rounds per minute.

A five-chambered drum at the rear end of the barrel is rotated in steps by means of a gas-operated slide which successively aligns each chamber with the barrel. The cartridges, held in hook-and-eye type links, are pulled into the gun by a star wheel feeder that rotates with the drum. The rounds are then chambered into the drum by a two-stage rammer attached to the slide. The round is fired electrically when it reaches the 12-o'clock position. After the drum has rotated another step, a finger-type extractor engages the rim of the

The over-all length of this weapon with flash reducer is 94 in., without flash reducer, 86 1/2 in; height is 9 in.; width is 10 in.; and weight, including barrel, is 243 lb.

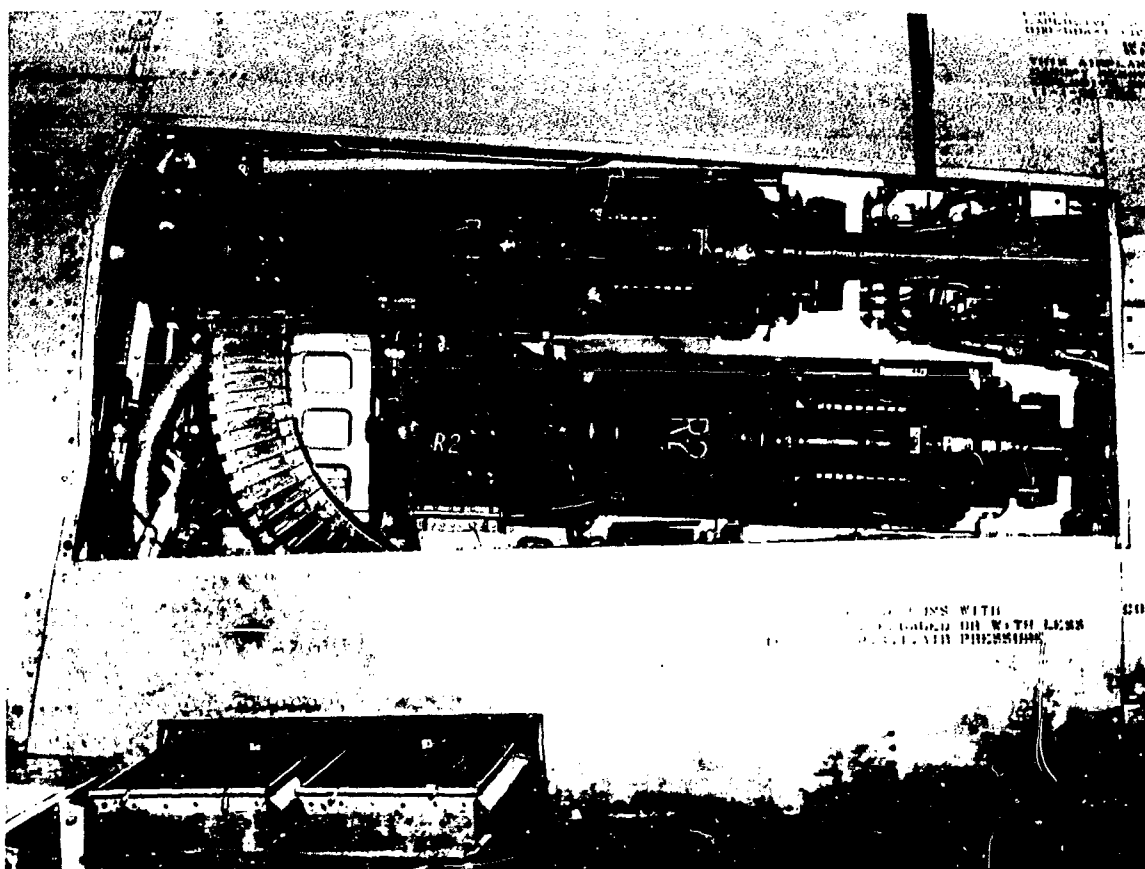
Fig. 3: The 206 RK Guns Installed in F-86F Aircraft

Four 206 RK guns are mounted in the F-86F test aircraft, two on each side of the fuselage (Fig. 3). Provision is made for the storage of 400 rounds (100 rounds per gun) of linked ammunition. Expended links are retained in the aircraft in order to minimize the movement of the center of gravity of the aircraft. Case ejection chutes are used to eject the expended cases from the aircraft.

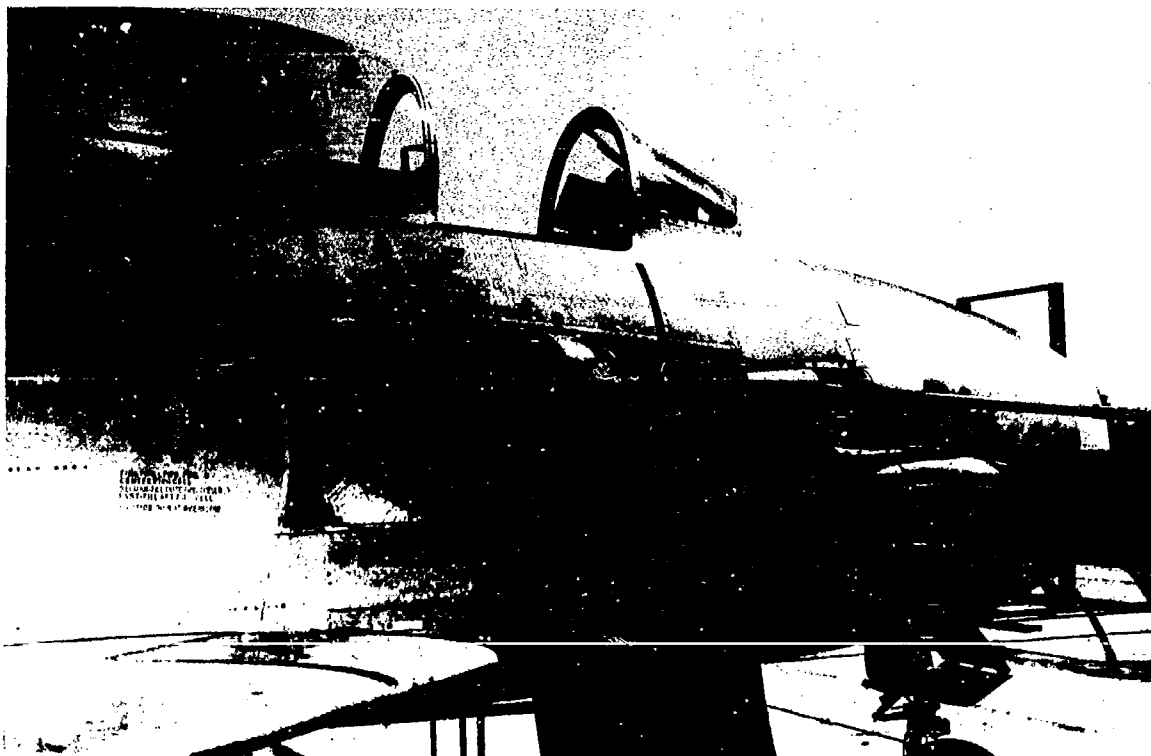
Fig. 4: View Showing Upper Right Gun Pivoted for Maintenance and Lower Right Gun in Normal Position

Access to the guns is facilitated by a mounting yoke at the forward end of the receiver. After the barrels are removed and the rear mounting lugs loosened, the gun can be pivoted as shown in Fig. 4 and serviced in that position.

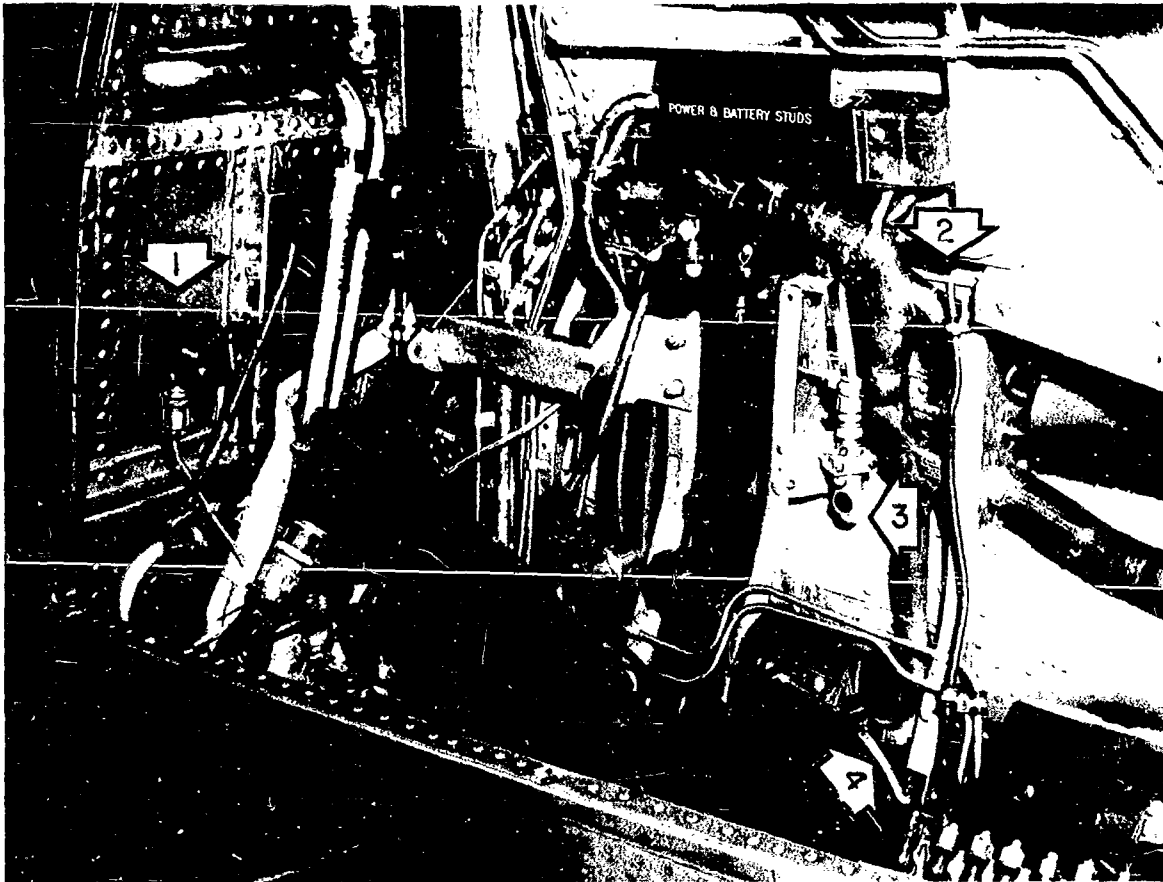
Fig. 7: Location of Fire-Eye Indicators (1 and 3) and Gun-Gas Pick-Ups (2 and 4) in Aft Portion of Right Gun Bay

A photoelectric-cell fire detection system (fire-eyes) consisting of eight cells (four in each gun bay) was installed to determine when flaming occurred. The output signal of the fire-eye was amplified and recorded on the oscillograph. Two of the fire-eye indicators are shown in Fig. 7.

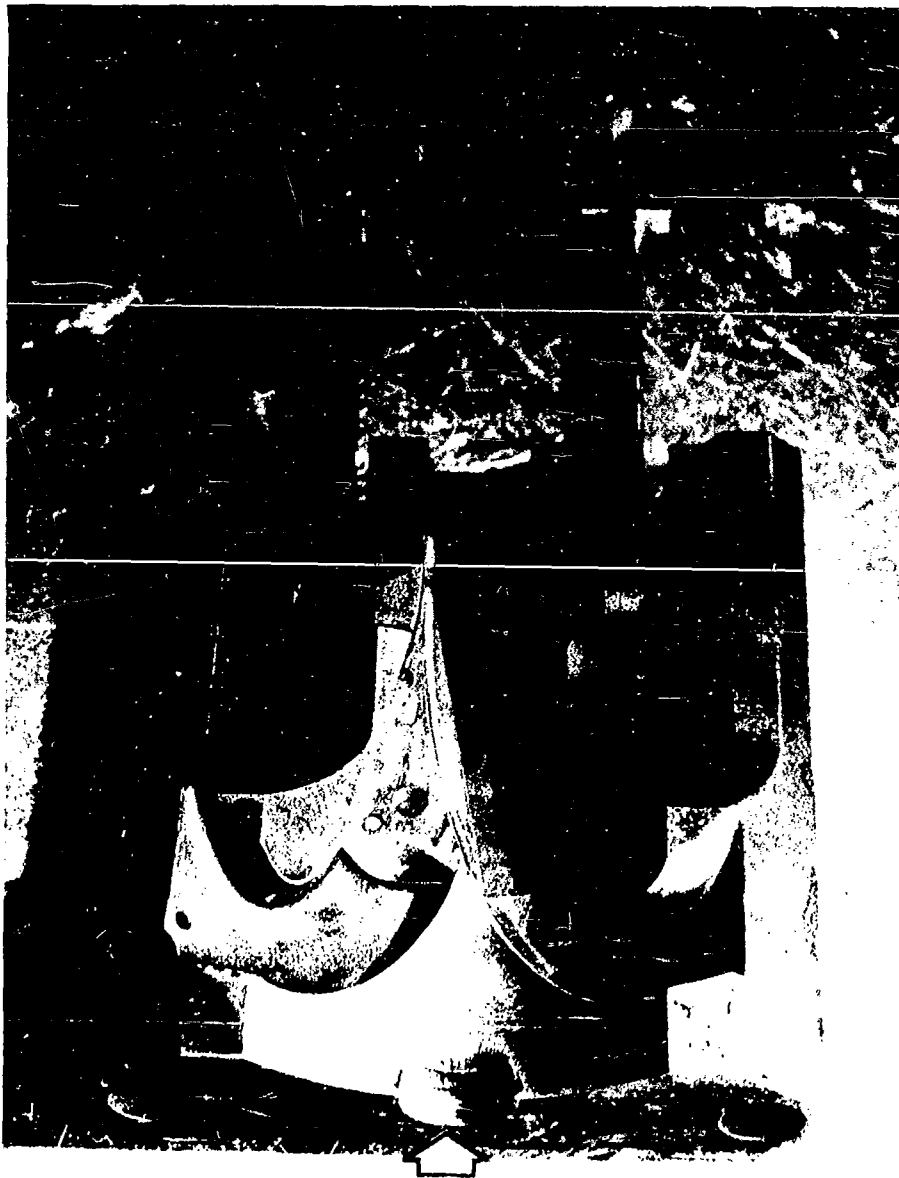
Fig. 12: Damaged Slide

After approximately 200 rounds had been fired, the slide became damaged by the gas piston (see Figs. 12 and 13). Only two stoppages were attributable to the slides (Table 1); in both instances the deformed slides prevented the drum from rotating.

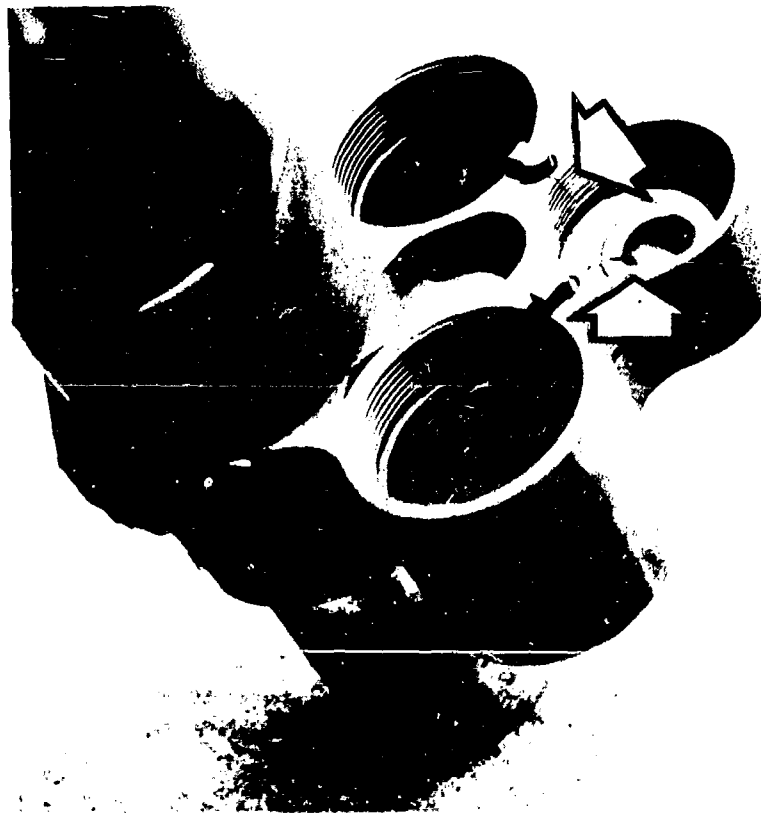
Fig. 14: View Showing Cracks in
the Gas Cylinder Bracket After
Firing 1286 Rounds

Metal fatigue, resulting from gun vibration, caused the gas cylinder brackets to crack (Fig. 14). This type of failure occurred in each of three guns after firing 1286, 1133, and 1321 rounds.
